## BELZONA® PROTECTION TO BUTANE TANK BASE

International Petroleum Company - Australia

2002

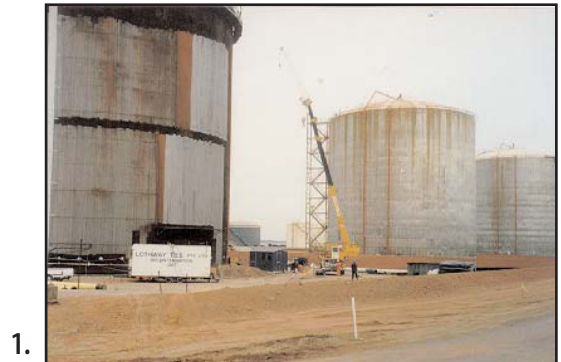
1. General view of the tank.
2. Preparation of tank and base underway. Tank jacked up ready to install new timbers.
3. Application underway.
4. Application being completed.
