## BELZONA PROVIDES LONG TERM PROTECTION AGAINST UNDER FLOOR CORROSION

Petrochemical Plant - UK

Carbon steel Paraxylene storage tank.

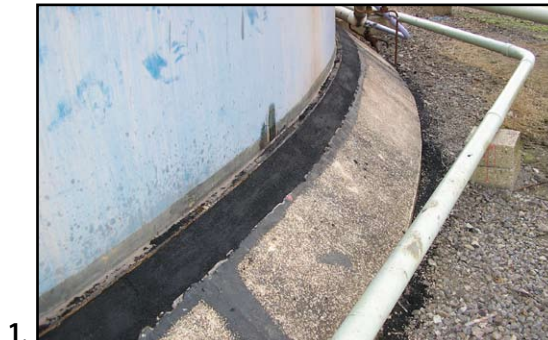
1. Before application of the Belzona system after new floor fitted
2. Application in progress
3. Application complete
4. Completed application over 2 years later

As a result of water ingress through the mastic type seal, under floor corrosion had occurred to an extent that the floor needed replacing. The customer was looking for a longer lasting, more effective base seal to satisfy government agency requirements.
