BELZONA RESTORES AND PROTECTS RIVER WATER PUMP

Petrochemical Plant, Louisiana U.S.A.

Cooling water pump drawing water from the Mississippi river.

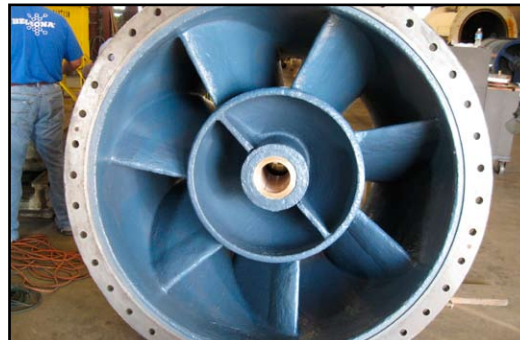
1. Rebuilt and protected suction bell
2. Impeller with first coat of Belzona[®] 1321(Grey)
3. Impeller fully protected with second coat Belzona[®] 1321
4. Suction diffuser fully restored

Pump was experiencing corrosion and cavitation erosion damage. Much of the casing was suffering from pitting caused by impingement.
