BELZONA PROVIDES INTERNAL PROTECTION OF GEARBOXES

Oil Refinery, UK

This is a typical small gearbox from a power plant within the refinery

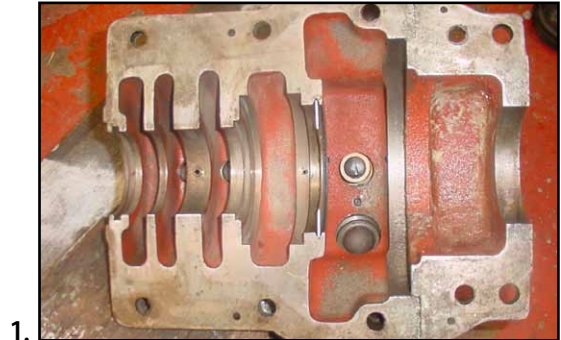
Original internal paint protection is flaking off and getting stuck in bearings and oilways. Loss of oil circulation can result in bearing damage and reduced efficiency.

1. Gearbox casing with damaged internal coating
2. Close up view of degraded paint coating
3. Close up view of Belzona[®] 5891 coating
4. Completed coating on casing

Belzona[®] 5891 (HT Immersion Grade)

Application carried out in accordance with Belzona Know-How System Leaflet TCC-5.
