BELZONA REBUILDS FLANGE FACE ON FILTER

Hydroelectric Power Plant, Russia

Rubber covered flange in the filter.

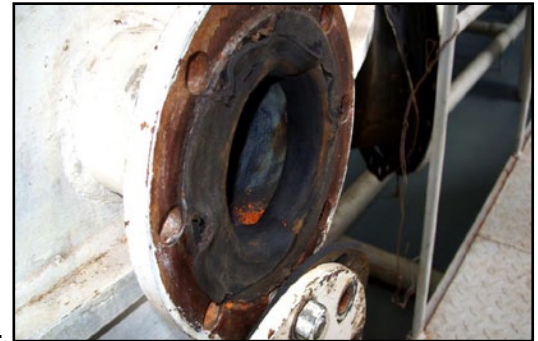
Rubber had been damaged due to long years in service and was badly deteriorated. Sealing of the flange lost. Rubber in seal area had lost adhesion to the substrate.

1. Deteriorated flange face before the application
2. Surface preparation to flange face
3. Completed application
