## STORM WATER PUMP PROTECTED WITH BELZONA FOR 10 YEARS

Replacement new vertical storm water pump

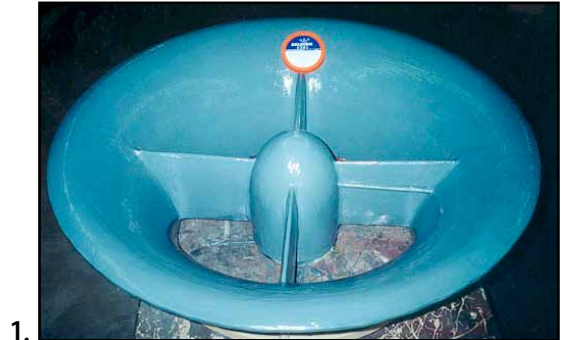
1. Suction Bell coated in 1998
2. Diffuser coated in 1998
3. Suction Bell in 2008
4. Diffuser in 2008

Application was carried out in accordance with Belzona Know-How System Leaflets CEP-3 & -4. New pump was disassembled at local repair facility. Suction bell and diffuser blasted and coated with Belzona® 1321 internally and Belzona® 5811 externally.

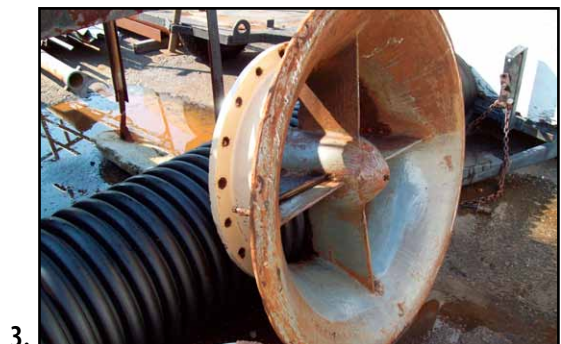
City personnel were very unhappy with the short service life of original vertical storm water pump. To protect the new pump from the damaging effects of the erosion corrosion cycle, Belzona coatings were applied. The new pump was retired after 10 years of successful service to replace it with a larger pump. An after service inspection revealed that 100% of the Belzona® 5811 was intact and 95+% of the Belzona® 1321 was intact.
