December
Newsletter

**Need to Repair Your Damaged
Shafts In-Place?**

Belzona® Repairs Conveyor Drive Shaft In-Situ

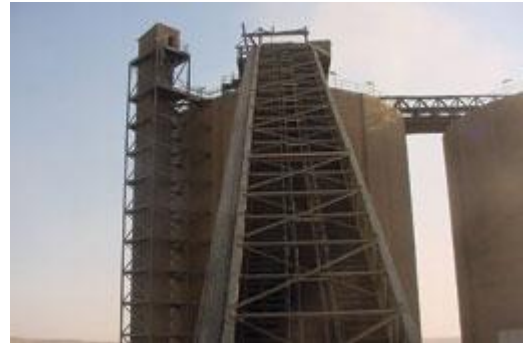
General View of Elevator Lifting Clinker Into Silos

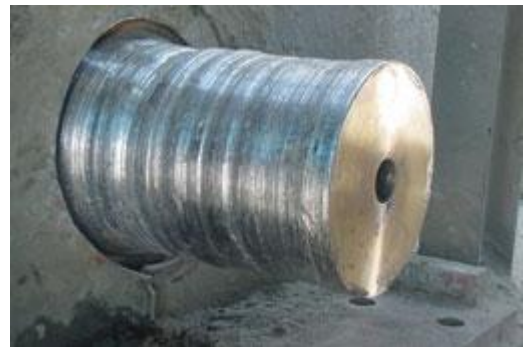
A cement works drive shaft was badly worn due to incorrect tightening of the adjustable sleeve which leads to relative motion between the shaft and the sleeve. The in-place repair was necessary and is a regular application of Belzona products. **Belzona® 1311 (Ceramic R-Metal)** was injected, using pneumatic injection pistol, into former constructed to restore correct shaft diameter. The Belzona® repair was carried out without need to remove shaft from the plant saving many days work.

Damage to the Shaft

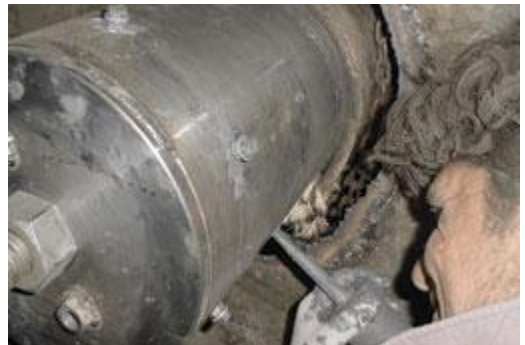
Former in place with injecting of the
Belzona® 1311 (Ceramic R-Metal)

Product and application technique selection should be made based on the cause and nature of damage and the operating conditions of the equipment. Suitable formers should be fabricated from rigid materials and split longitudinally. They should be of a suitable length to centralize the repair onto undamaged sections of the shaft.

Belzona® 1311 (Ceramic R-Metal) was used in this repair since repairing and rebuilding damaged metal surfaces is one of the purposes of this product.

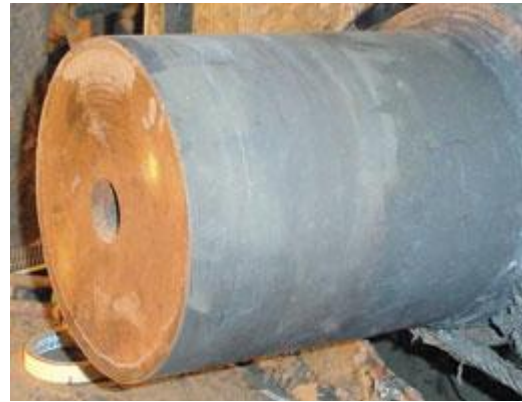
Accurate diameter restored to the shaft
