Repair Pumps and Up Efficiency | July 2009

Des Moines Water Works Saves with Belzona®:

Des Moines, Iowa USA - In the fall of 2003, vibration analysis indicated a bearing problem with one of two main Worthington 1000 H.P. 17 million gallons per day pumps. These two pumps were put into service in 1989 and have been running side by side of each other, pumping finished/potable water since then.

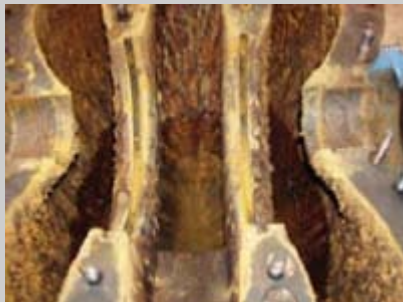
Corroded Pump Volute

A teardown was scheduled to rebuild the pump, and 3E Co. was already on site repairing other pumps with Belzona. Therefore it was decided to coat this pump with Belzona® 1341 (Supermetalgilde) for many important reasons:

They were about to be surprised! For the application to commence offsite, the pump was lifted out of the building through a side window and transported to be grit blasted. This was followed by two coats of Belzona® 1341 (Supermetalgilde) applied. After the coating process was completed on the pump volute itself, the brass impeller was also grit blasted, coated and balanced. The pump was returned, lifted back into place and returned to service. Since the remaining pump has not yet been coated, the opportunity to coat the sister pumps allowed the customer to compare one against the other.

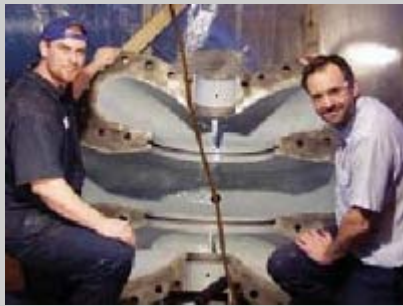
Final Coating Inspection
