*Rumford Industrial Group Inc.*

**Chemical Containment Area Repair | August 2009**

***Belzona® Repairs and Improves Containment Areas:***

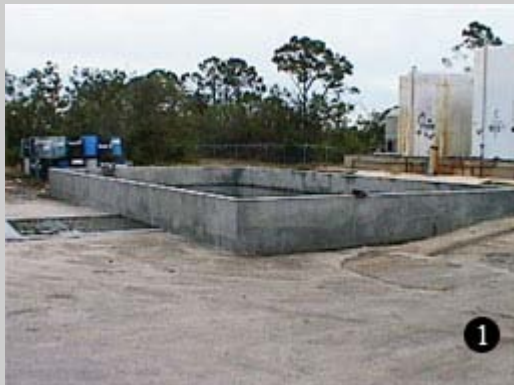
**General view of the containment area.**

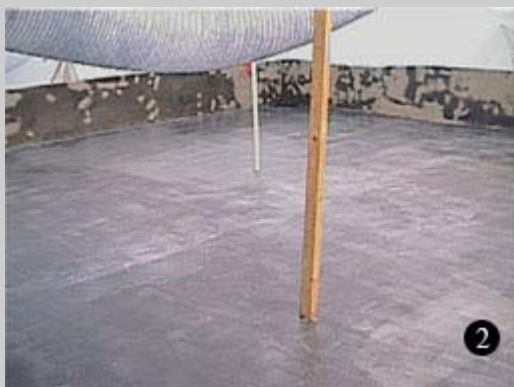
**Belzona® 4911 and Belzona® 4141 applied.**

Old containment’s rubber liner had failed from use and UV damage. Protection of new containment was required for continued use of acid mix down plant.

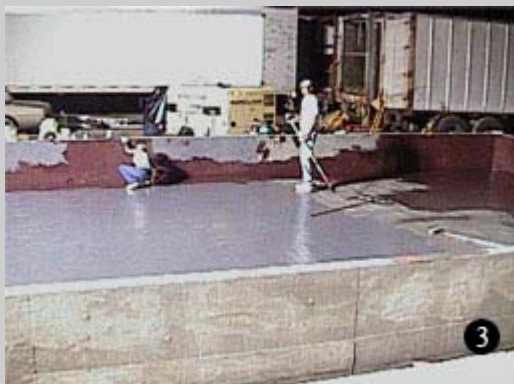
**Belzona® 4311 coat interrupted.**

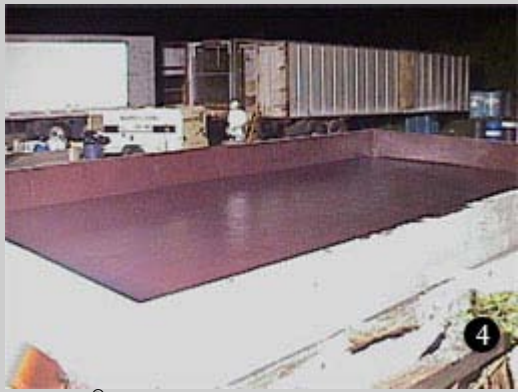
Belzona® 4311 applied over night, completing the application process.
