Rumford Industrial Group Inc.

Extend Heat Exchanger / Chiller Life | September 2009

SHELL & TUBE CHILLERS / HEAT EXCHANGER

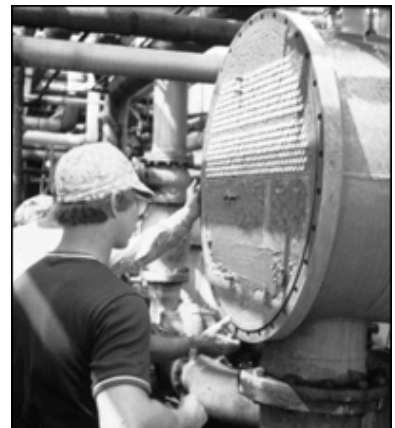
- Rebuild and protect eroded-corroded tube sheets

Predominantly chiller /heat exchanger tubes are manufactured from a different metal than the tube sheet. This leads to bi-metallic corrosion at the junction of tube and tube sheet which in turn causes leakage across the tube sheet.

Because Belzona products are electrically non-conductive they can be used to isolate the twodiffering metals from the electrolyte thus breaking the electrical connection and thereby eliminating the galvanic corrosion.

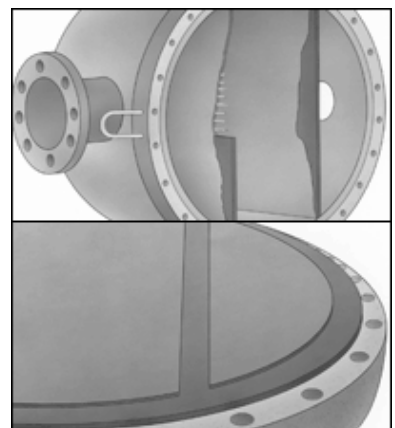
- Rebuild division bars and seal faces

- Reform division bar seats.
- Rebuild covers and water boxes.

When division bars and their seats (seal area) are damage by corrosion the result is short circuiting of the fluid media between passes. This of course drastically reduces the efficiency

of the heat exchanger.

Rebuild division bars and seats with Belzona Erosion-Corrosion resistant products. Belzona forming techniques ensure perfect corrosion resistant mating surfaces.

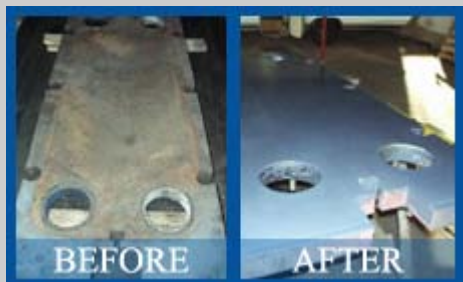
The steel ends of the "**plate type**" **heat exchangers** can become corroded and cause leaking.

Galvanic and crevice corrosion on the plates result in leaking around the steel and a loss of efficiency.

Using a modified version of Belzona's engineering specifications, a plate is coated with Belzona® 9411 and used to form a thick layer of Belzona 1341 on the end cover. This procedure provides a perfect finish and excellent seal.

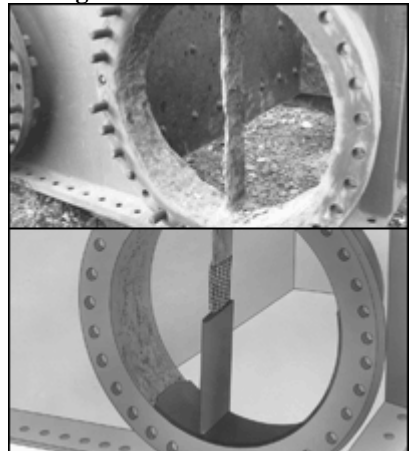
- Protect water boxes and end covers against corrosion

Corrosion build up within waterboxes can lead to reduced turbulent flow of the fluid passing through. This in turn will lead to increased erosion and also reduce the efficiency of the heat exchanger.

By applying a Belzona protective coating the corrosion can be eliminated. If the corrosion is eliminated the consequences of the corrosion are also eliminated. Various coatings are available which are designed to cope with a range of service conditions.
