Rumford Industrial Group Inc.

Cooling Tower Fan Blade Repair/Protection | October 2009

FAN BLADE EDGES REBUILT WITH BELZONA®

- Rebuild and protect damaged cooling tower fan blade edges

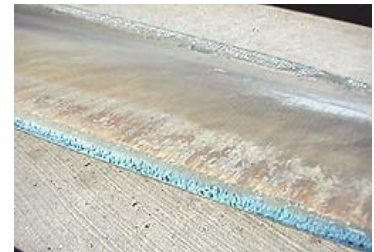
UV degradation, erosion and impingement had caused damage to both the leading and trailing edges of the cooling tower fan blades. This, in turn, caused inefficient tower operation and raised concerns about blade replacement in the near future.

[Belzona® 1321 \(Ceramic S-Metal\)](#)

Belzona Know-How Leaflet FBC-1

This huge cooling tower has ten individual cells. Each cell contains eight cooling tower blades, and all ten cells were refurbished with the aforementioned Belzona Know-How technique.
