BELZONA PROTECTS CAUSTIC CONTAINMENT AREA

Power Plant, Alabama USA

Caustic Containment Area in water treatment plant.

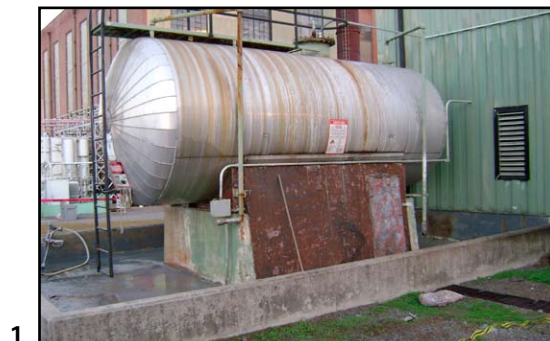
Customers Caustic Containment Area coating had failed and needed a new impervious coating installed.

1. Containment before old coating removed
2. Containment after old coating removed
3. & 4. Completed application
