## BELZONA PROTECTS NEWLY CONSTRUCTED CONTAINMENT AREA

Petrochemical Plant, Canada

Newly constructed containment area needed protection before installing tanks and other equipment.

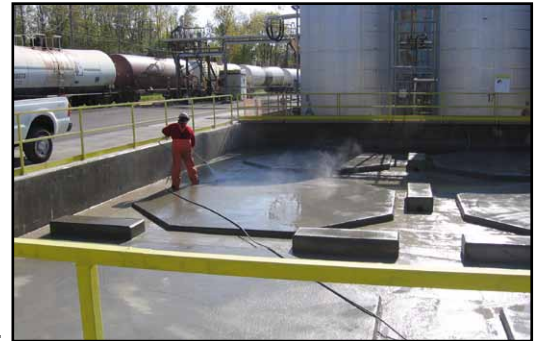
1. Surface preparation with high pressure wash
2. Application of Belzona® 4911 Conditioner
3. Application of Belzona® 4111 to create a fillet on wall/floor junctions.
4. Application of Belzona® 5811 (beige and grey colors used)
